MARYLAND HISTORICAL TRUST
DETERMINATION OF ELIGIBILITY FORM

Property Name: SHA Bridge No. 15033 (Sligo Creek Bridge) Inventory Number: M: 37-7
Address: MD 195 (Carroll Avenue) over Sligo Creek Historic district: yes no
City: Takoma Park Zip Code: _____ County: Montgomery
USGS Quadrangle(s): Washington West
Property Owner: State Highway Administration Tax Account ID Number: _____
Tax Map Parcel Number(s): _____ Tax Map Number: _____
Project: Historic Bridge Inventory Agency: SHA
Agency Prepared By: _____
Preparer's Name: _____ Date Prepared: _____
Documentation is presented in: _____
Preparer's Eligibility Recommendation: _____ Eligibility recommended _____ Eligibility not recommended
Criteria: A B C D Considerations: A B C D E F G
Complete if the property is a contributing or non-contributing resource to a NR district/property:
Name of the District/Property: _____
Inventory Number: _____ Eligible: yes Listed: yes
Site visit by MHT Staff yes no Name: _____ Date: _____

Name: Sligo Creek Bridge, MD 195 over Sligo Creek

SHA Bridge No. 15033 Name: MD 195 over Sligo Creek (Sligo Creek Bridge)

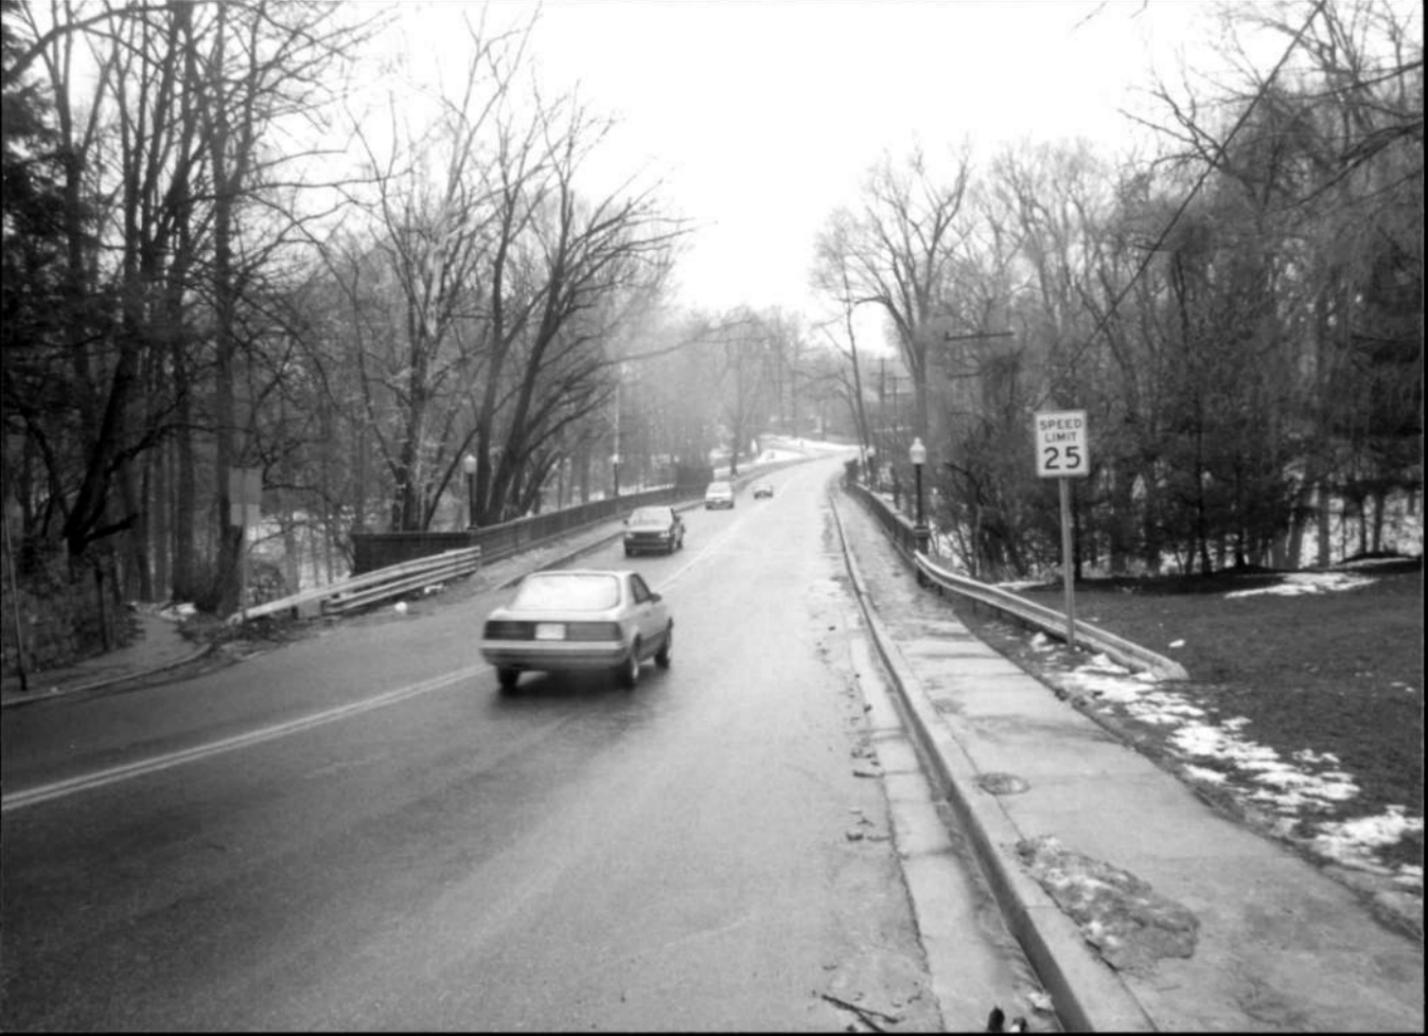
Number ¹24 of ~~31~~ ⁴⁹⁷

Description APPROACH WEST

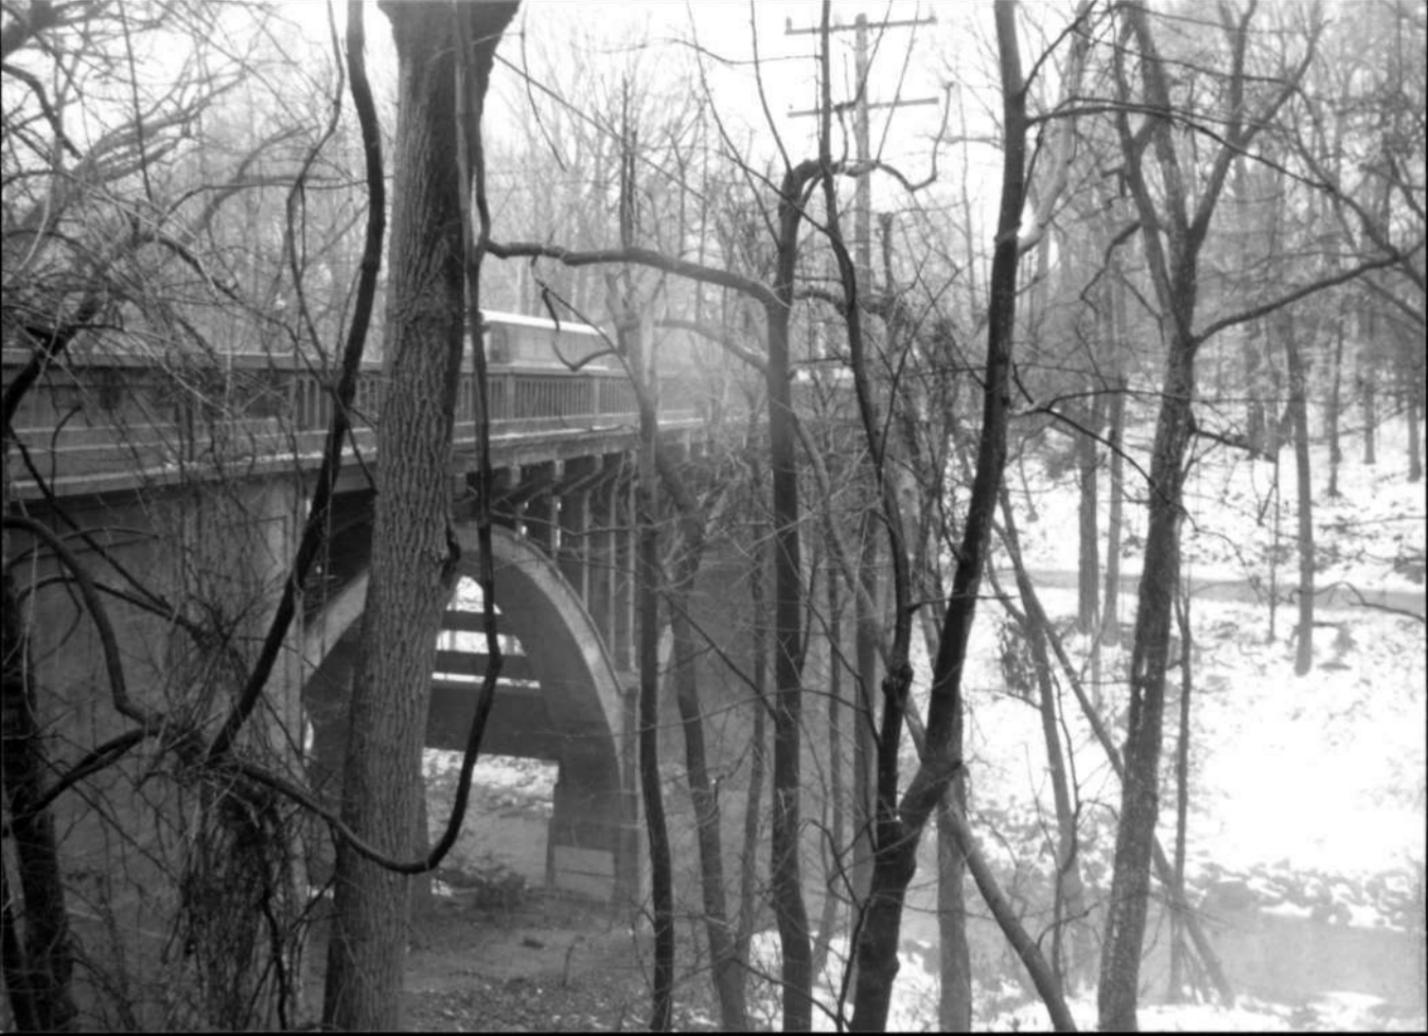
Number ²~~25~~ of ~~34~~³⁷

Description ELEVATION SOUTH

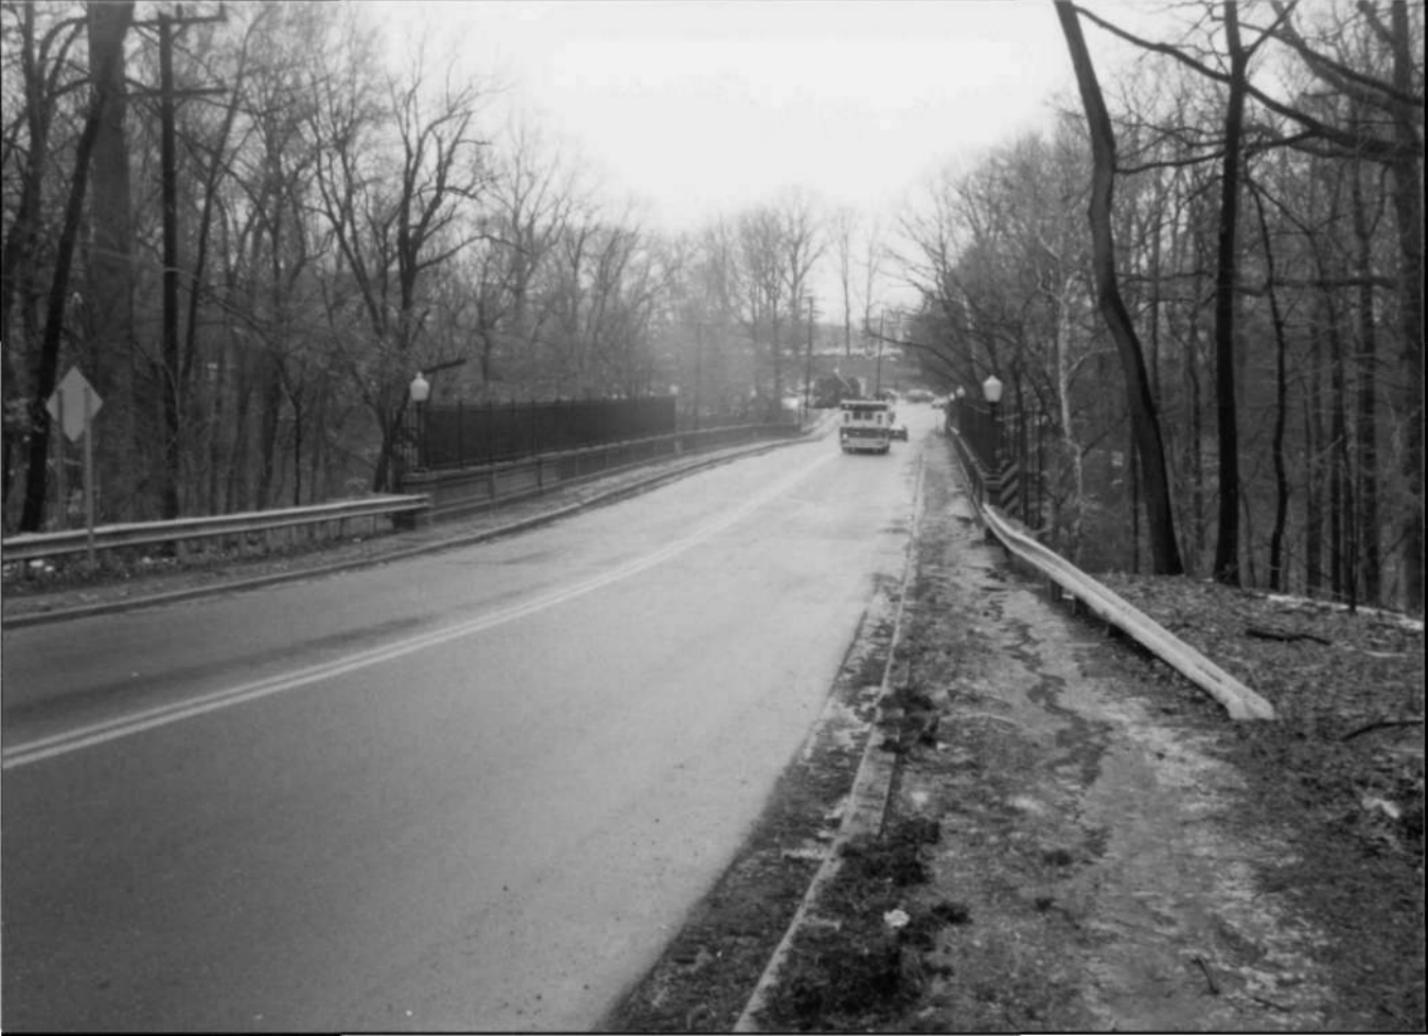
Number ~~4~~ ~~27~~ of ~~34~~ ~~9~~ 3 of 7

Description APPROACH EAST

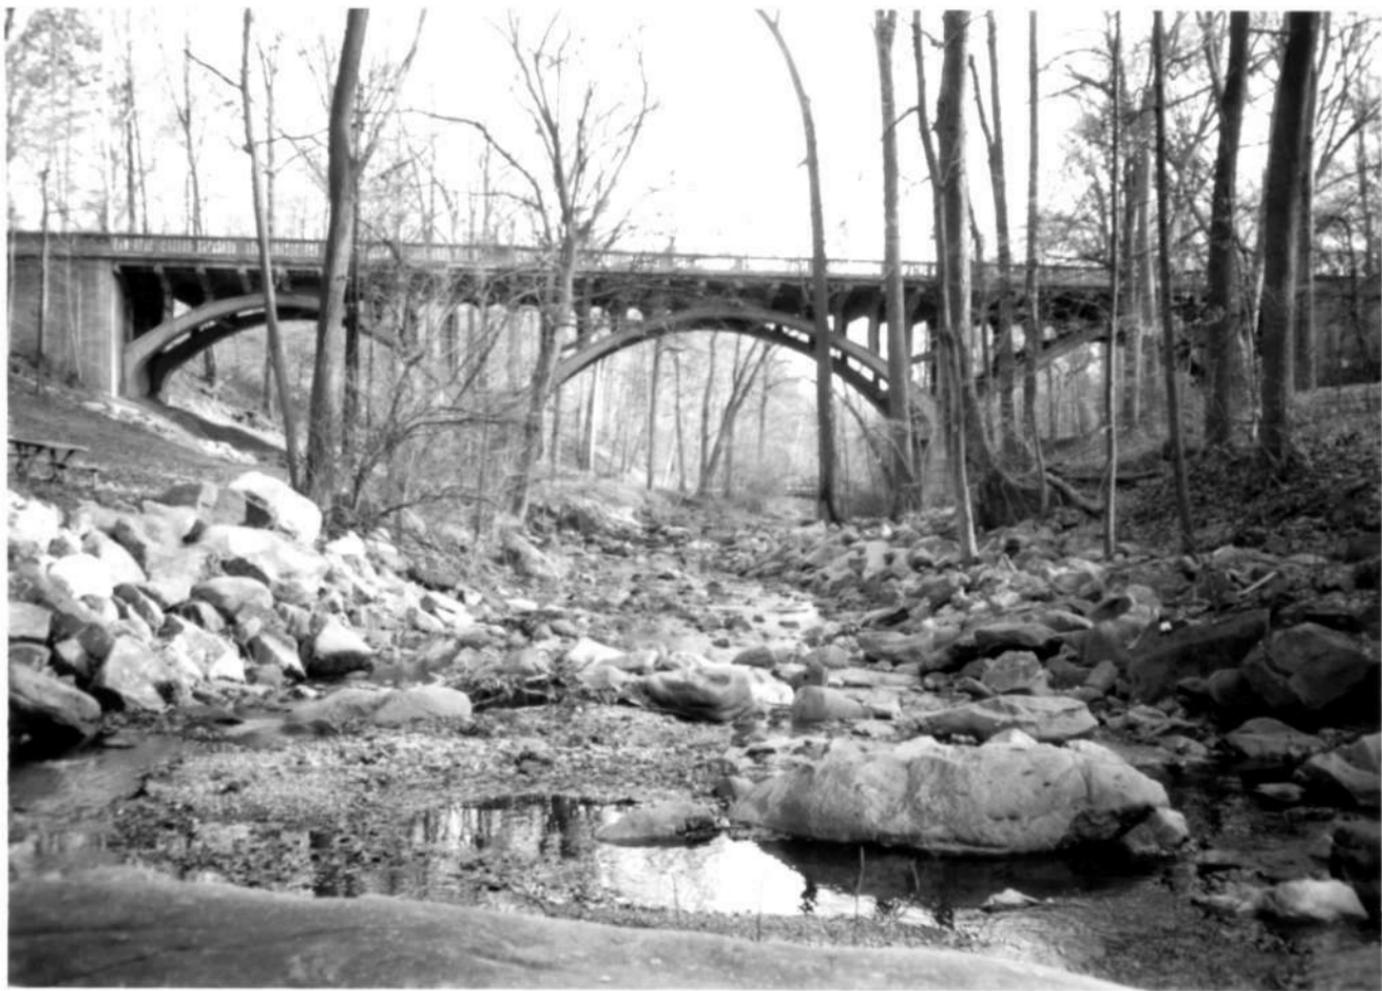
1. M:37-7
2. MD 195 over Sligo Creek
3. Montgomery Co., MD
4. Wallace, Montgomery & Assoc.
5. 12/97
6. MD SHPD
7. Elevation looking downstream
8. 4 of 7

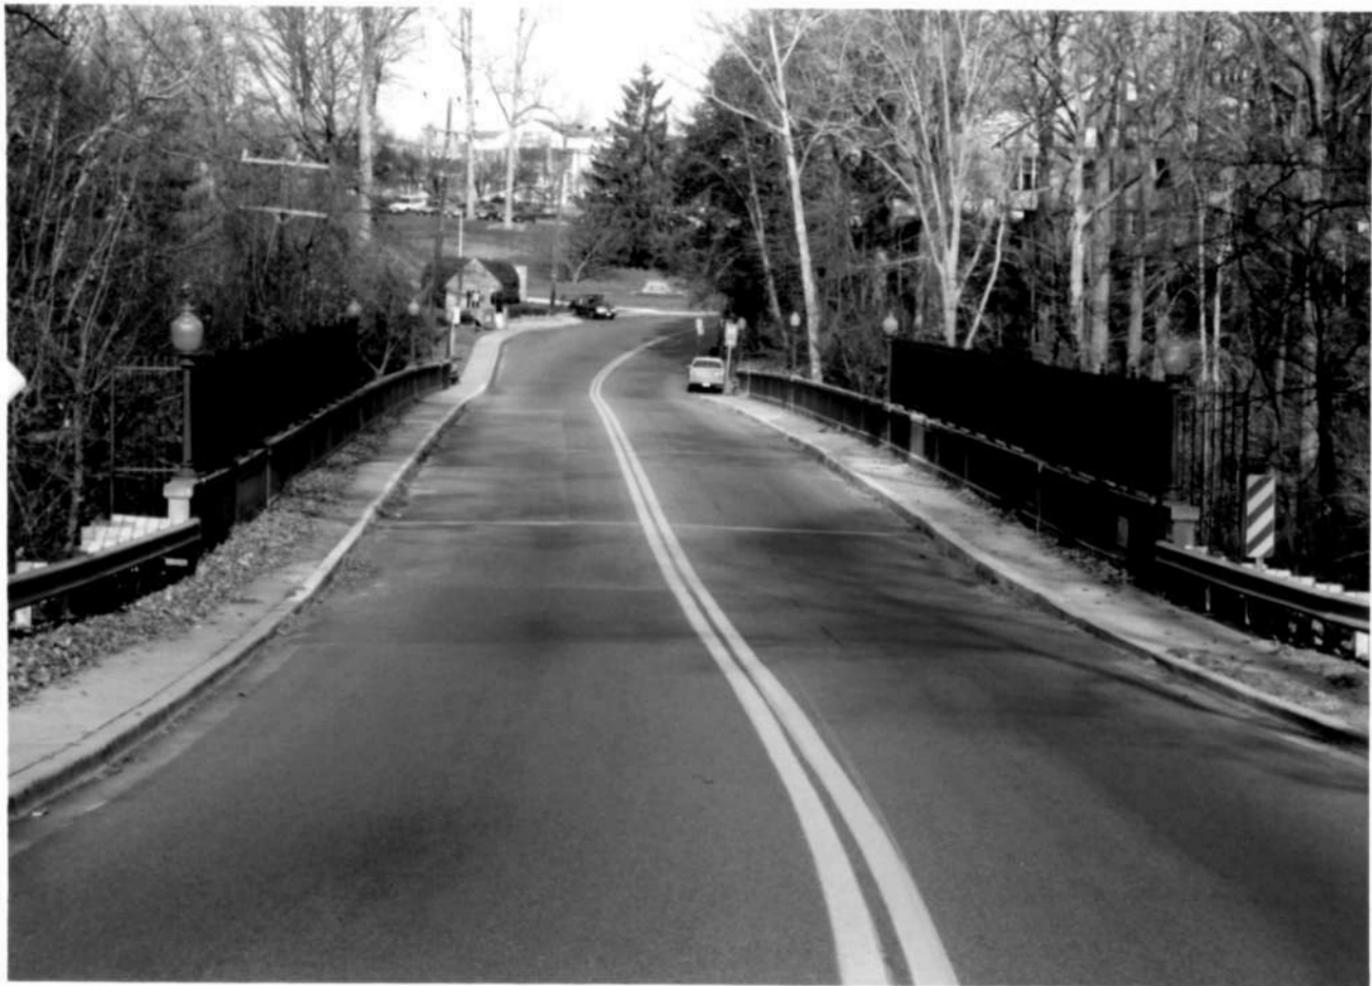
1. M:37-7
2. MD 195 over Sligo Creek
3. Montgomery Co., MD
4. Wallace, Montgomery & Assoc,
5. 12/97
6. MD SHPO
7. Looking East
8. 6 of 7

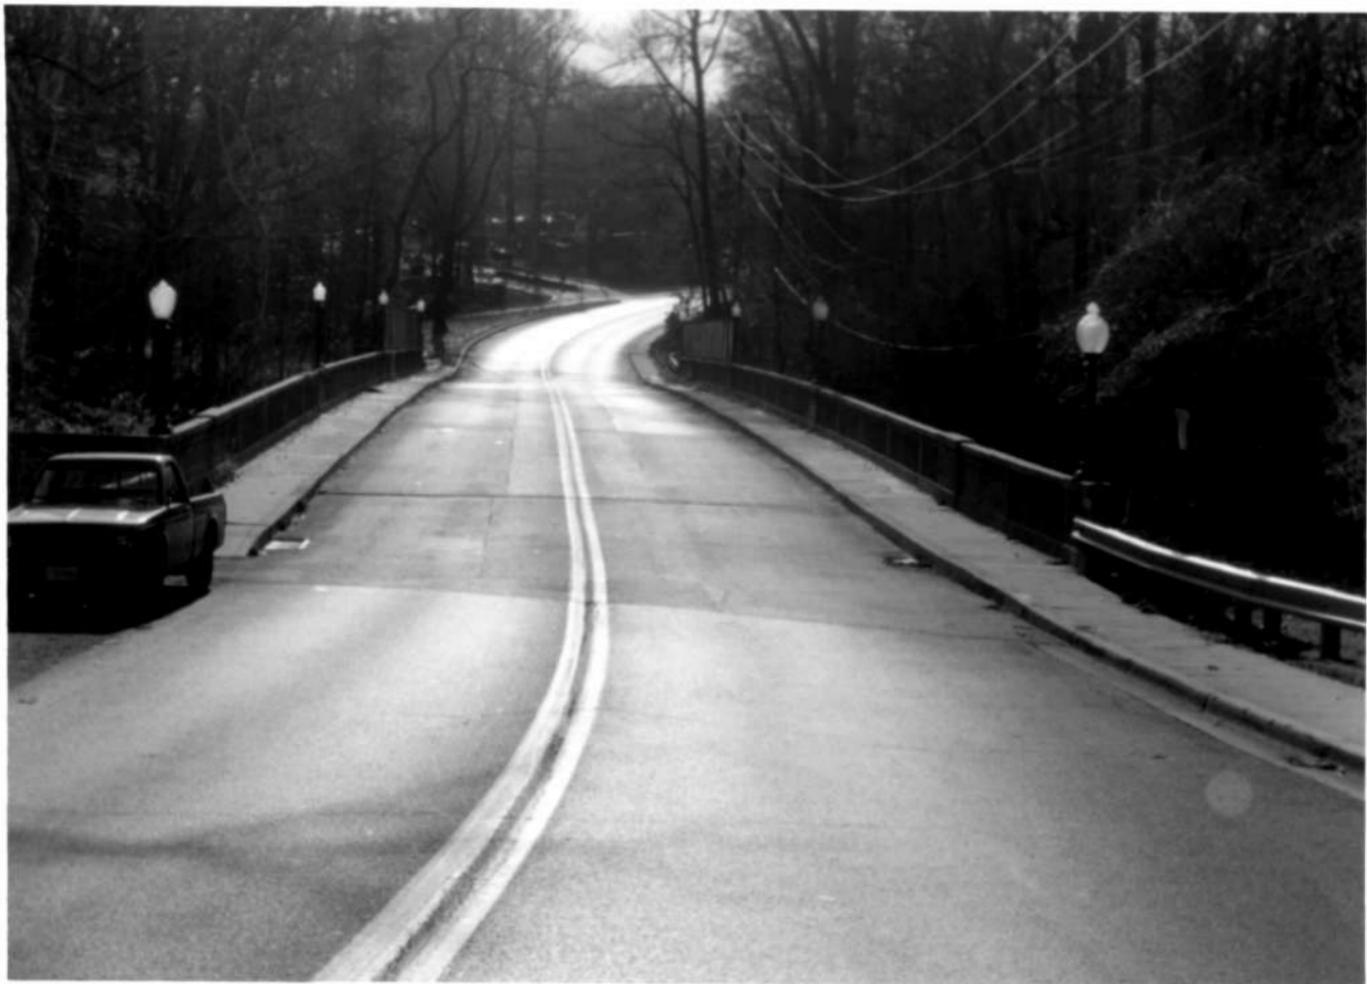
1. M:37-7
2. MD 195 over Sligo Creek
3. Montgomery Co., MD
4. Wallace, Montgomery & Assoc.,
5. 12/97
6. MD SHPO
7. Looking West
8. 7 of 7
